**ASTM E 90 SOUND TRANSMISSION LOSS
TEST REPORT**

THERMA-TRU DOORS

SERIES/MODEL: Slimline

TYPE: 6/8 Sliding Patio Door with Impact Glass

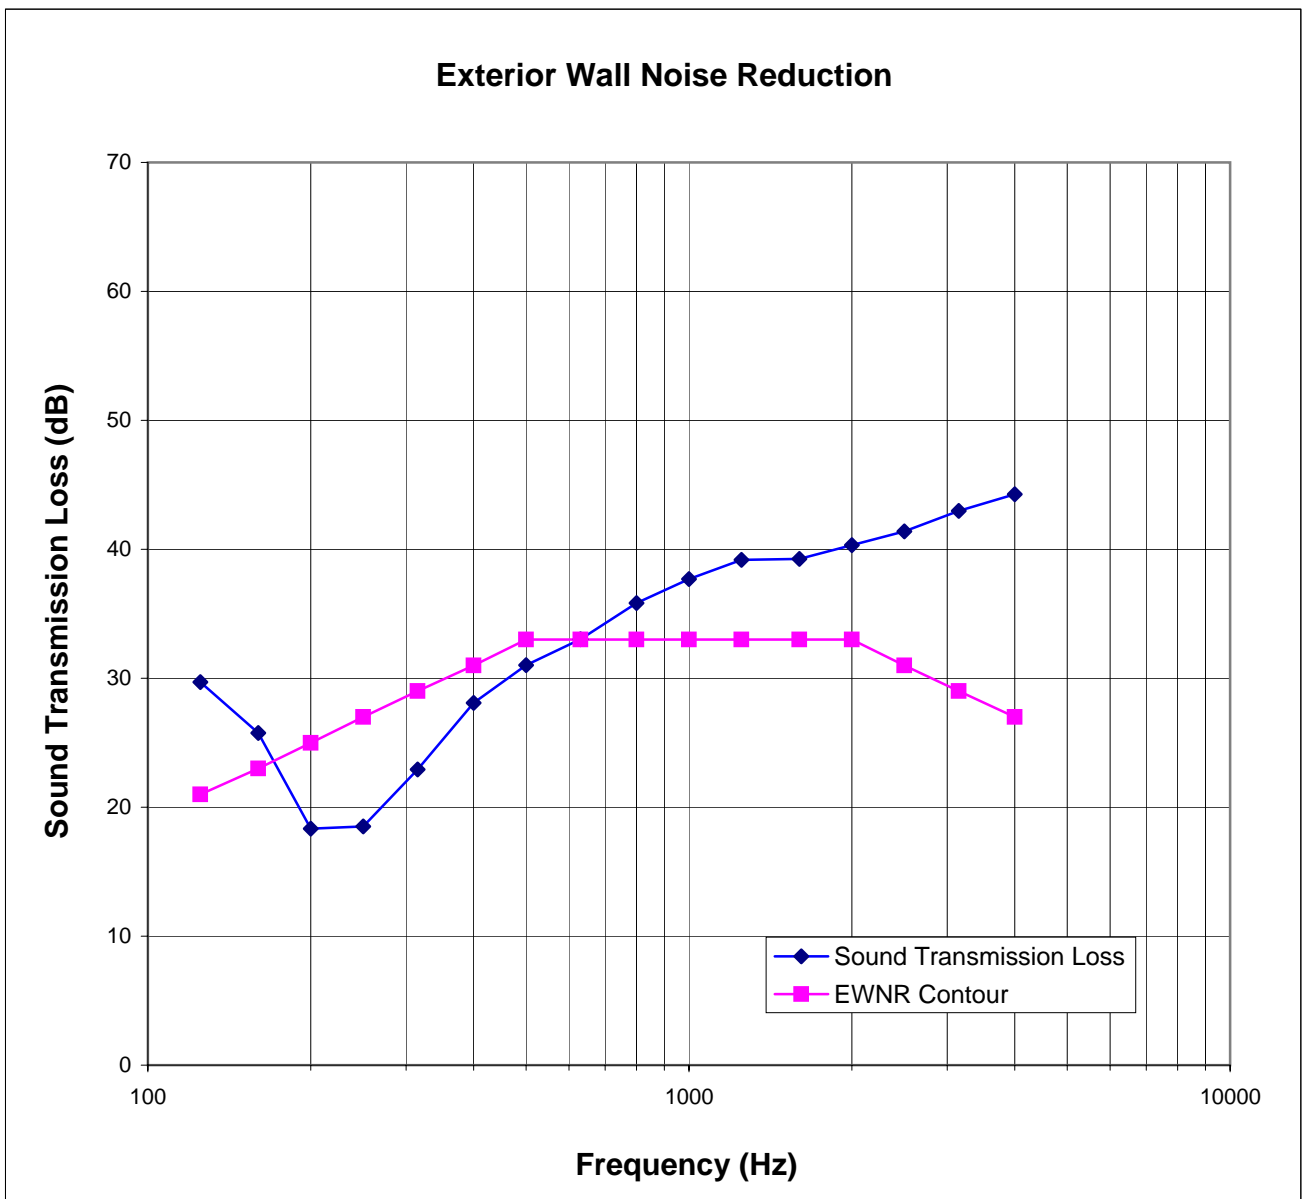
ATI No. 74392.01A Date 08/22/07
Client Therma-Tru Doors
Specimen Series/Model: Slimline, 6/8 sliding patio door with impact glass with 15/16" IG (5/16" laminated exterior, 1/2" air space, 1/8" tempered interior) inoperable test, both sides duct taped, SPL test
Specimen Area 39.34 Sq Ft
Filler Area 100.66 Sq Ft
Operator Kurt A. Golden

STC Rating = 34 *(Sound Transmission Class)*
Deficiencies = 31 *(Number of deficiencies versus contour curve)*
OITC Rating = 27 *(Outdoor/Indoor Transmission Class)*
EWNR Rating = 33 *(Exterior Wall Noise Reduction)*

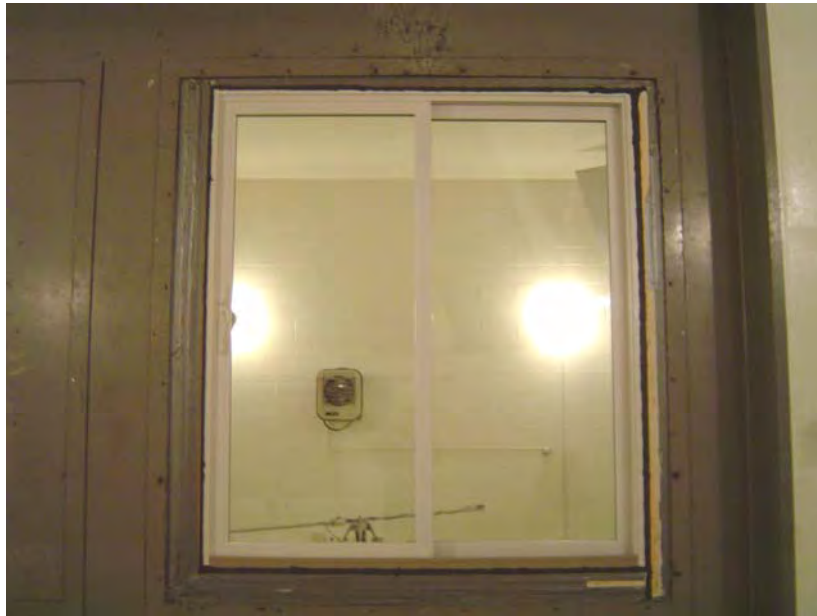
Receive Room View of Installed Specimen

The 80" by 86" plug was removed from the filler wall assembly. A 2" x 8" wood frame was used to reduce the test opening size to 71-3/4" by 80". The 6/8 sliding patio door with impact glass was placed on a foam isolation pad in the test opening. Duct seal was used to seal the perimeter of the test specimen to the test opening on both sides. The interior side of the 6/8 sliding patio door with impact glass frame, when installed, was approximately 1/4" from being flush with the receiving room side of the filler wall. A stethoscope was used to check for any abnormal air leaks around the test specimen prior to testing. The operable panel was opened and closed at least five times prior to testing.
